**FEASIBILITY STUDY OF USING COMPOSITE MATERIALS FOR  
TRACTION MOTOR BEARINGS**

Transportation Development Centre  
of  
Transport Canada

National Research Council Canada  
Institute for Aerospace Research  
Structures, Materials and Propulsion Laboratory

TP 14160E

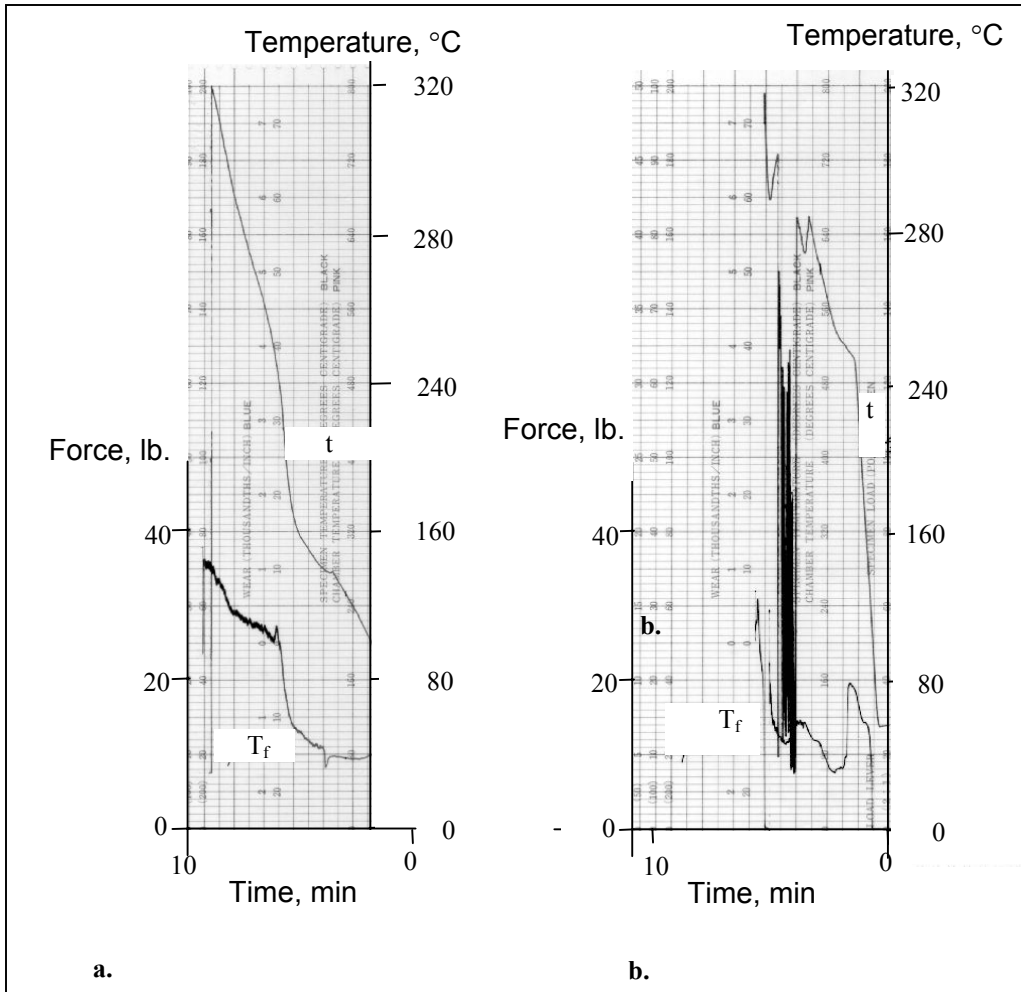
**Figure 5 Data from the failed tests: T<sub>f</sub> - friction force, t - block temperature**  
**a.** DP4, 0.392 kN (88 lb.), 732 rpm  
**b.** Vespel<sup>®</sup> SP21, 0.154 kN (35 lb.), 3170 rpm

A summary of the test results is presented in Table 3. Three of the test materials did not perform satisfactorily at all test conditions. Examples of data collected from the failed tests on the DP4 and Vespel<sup>®</sup> SP21 materials are shown in Figure 5. Rapid growth of both the block's temperature and friction force terminated the test.

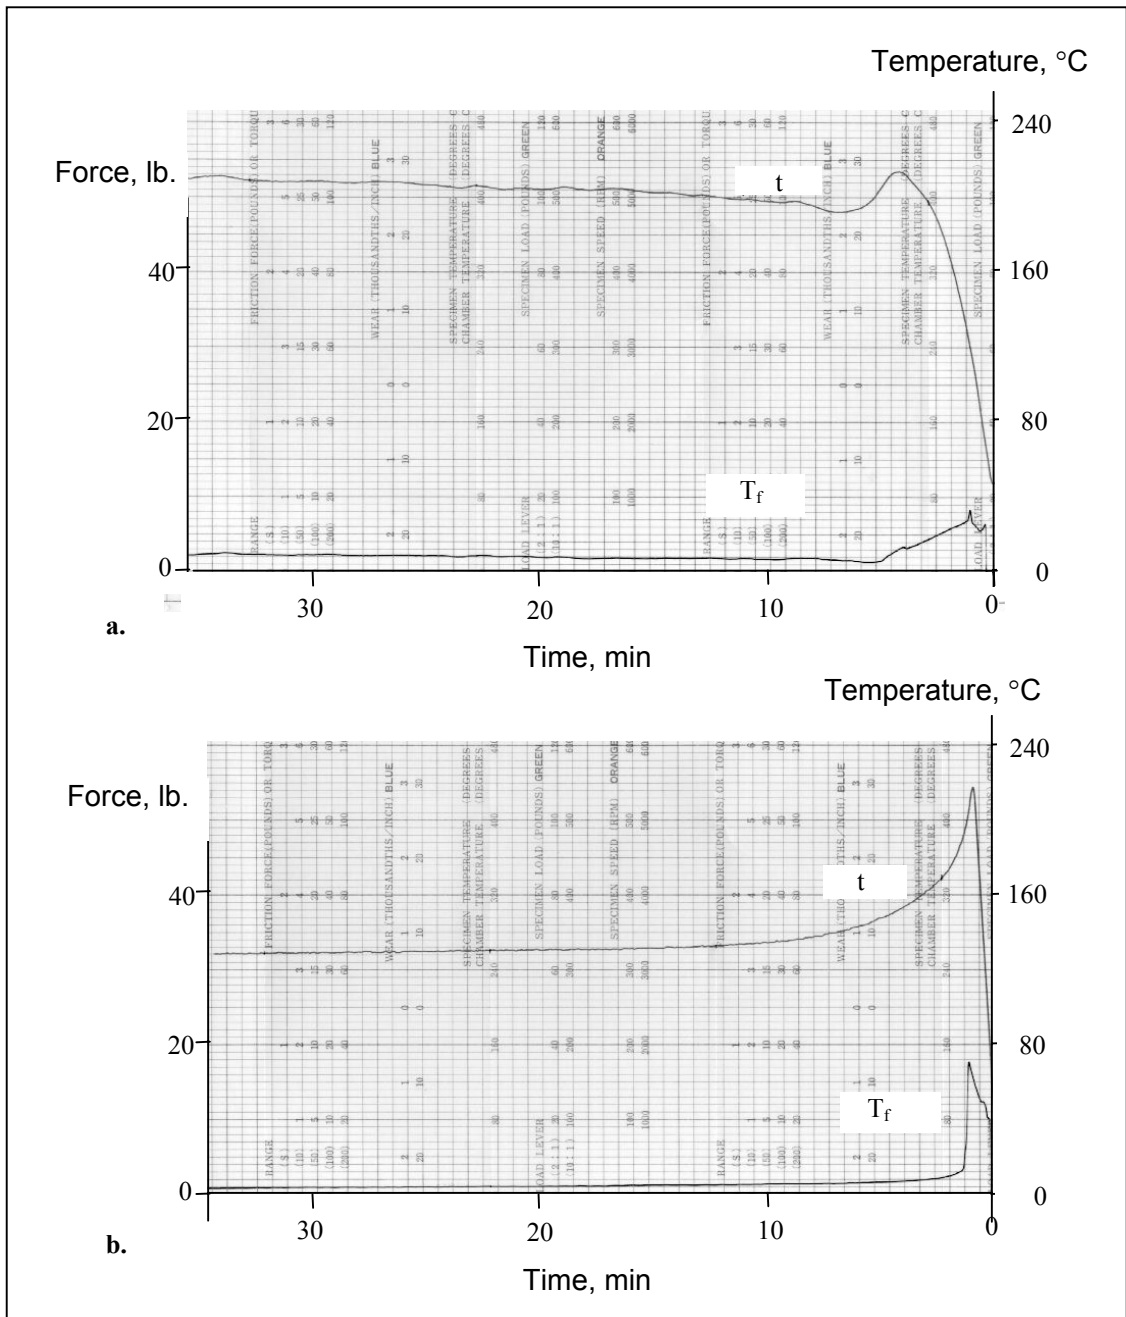
**Figure 6** Data from the tests at the highest  $pv$  factor (35 lb., 3170 rpm):  $T_f$  - friction force,  $t$  - block temperature  
 a. FM3000    b. Vespel® SP214X

Vespel<sup>®</sup> SP214X and FM3000 withstood all the test conditions. Figure 6 illustrates the performance of these two materials at the highest  $p_v$  factor. A comparison of the results from these two materials showed that the Vespel<sup>®</sup> SP214X was superior, in terms of exhibiting significantly lower block temperature, wear and friction coefficient (see Table 2 and Figure 6).

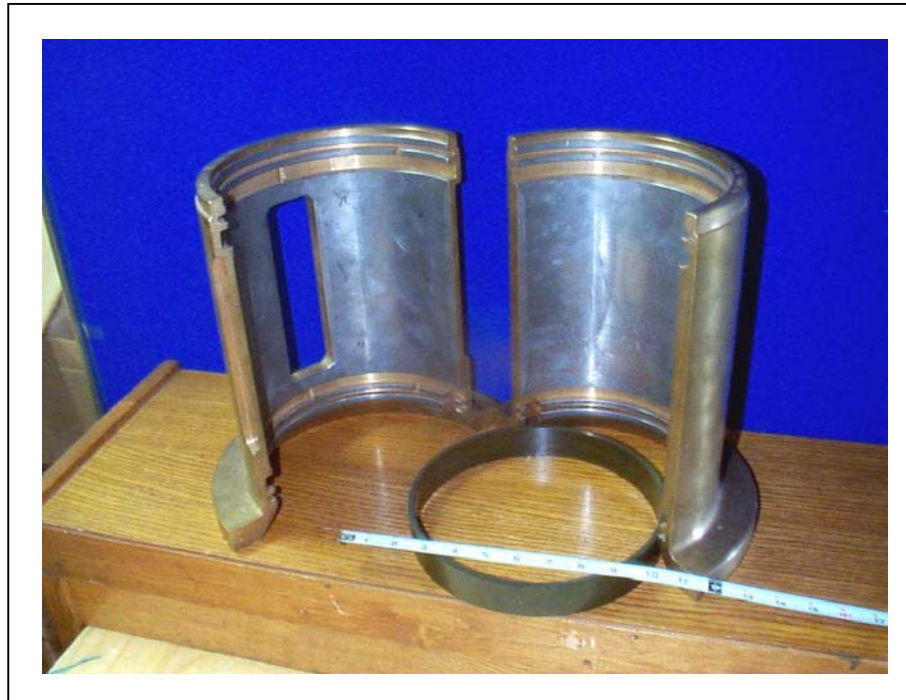
**Figure 8 Babbitt-lined traction motor bearing (with Vespel<sup>®</sup> ring in the foreground)**

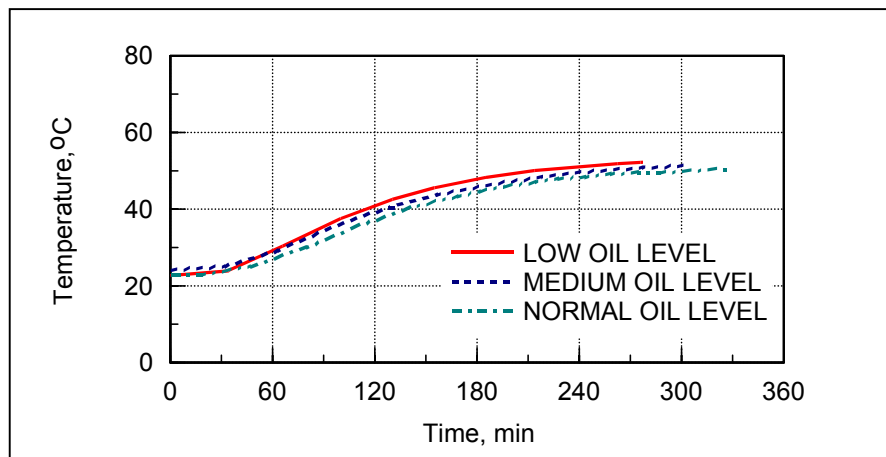
**Figure 11** Stabilization of the reservoir oil temperature. Bearing load 16,100 lb., shaft speed 538 rpm

Prior to collecting data from the bearing, the oil and bearing temperatures were stabilized. This usually took between 5 and 7 hours, depending on shaft speed and load. Generally, the lower the shaft speed the longer the stabilization time. Oil level in the reservoir had a negligible effect on the stabilization time, as shown in Figure 11. Here, reservoir oil temperature is plotted against time for a speed of 538 rpm and a load of 16,100 lb.

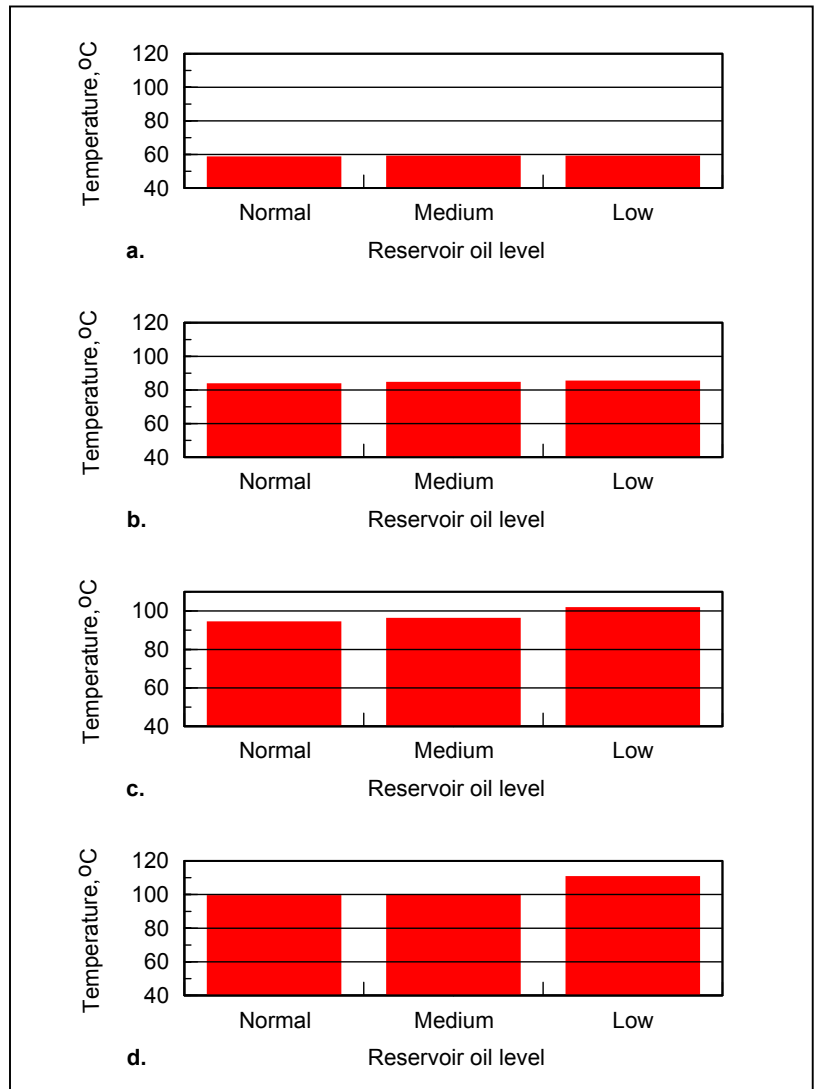
**Figure 13 Effect of bearing operating conditions and reservoir oil level on maximum bearing temperature**  
 a. 106 rpm/40,900 lb.      b. 295 rpm/25,500 lb.  
 c. 458 rpm/18,100 lb.      d. 538 rpm/16,100 lb.

Consequently, reservoir oil level had little effect on bearing operating temperatures. However, bearing temperatures were more sensitive to shaft speed. A maximum bearing surface temperature of 111°C was recorded at 538 rpm and 16,100 lb., with the low reservoir oil. Figure 13 shows the recorded maximum bearing temperature for different reservoir oil levels and operating conditions, while Figure 14 compares the bearing temperature profiles for different loads and speeds with the normal oil level. At the highest shaft speed of 538 rpm, and the bearing load of 16,100 lb., the maximum bearing temperature exceeded 100°C.

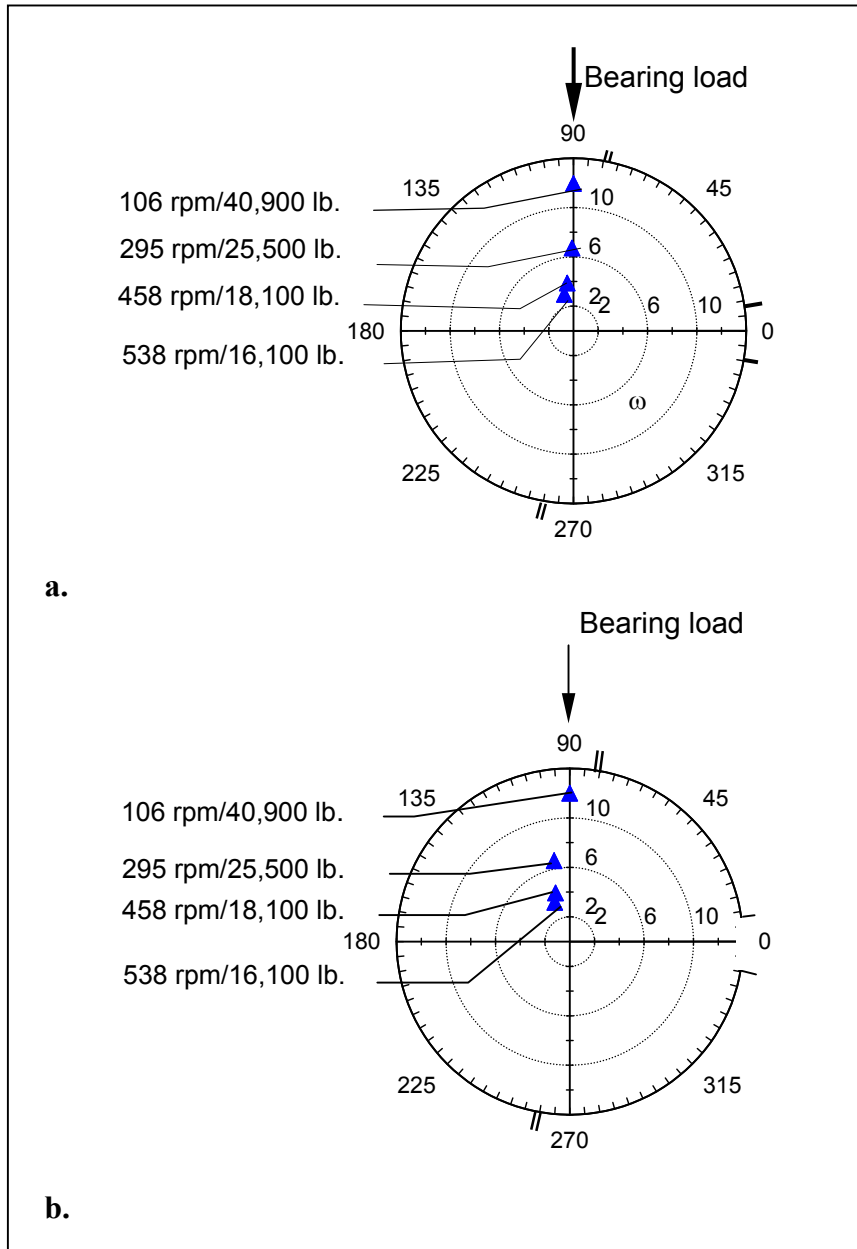
**Figure 16 Journal centre location within the bearing clearance circle ( $10^{-3}$  in.)**  
 a. normal reservoir oil level    b. low reservoir oil level

A relatively weak dependence of reservoir oil level on the displacement measurements was also observed. Displacement measurements for both the normal and low oil levels are illustrated in Figure 16. It can be concluded that, within the range of the tests conducted in this study, oil level has little or no effect on the thickness of the oil film in the bearing.

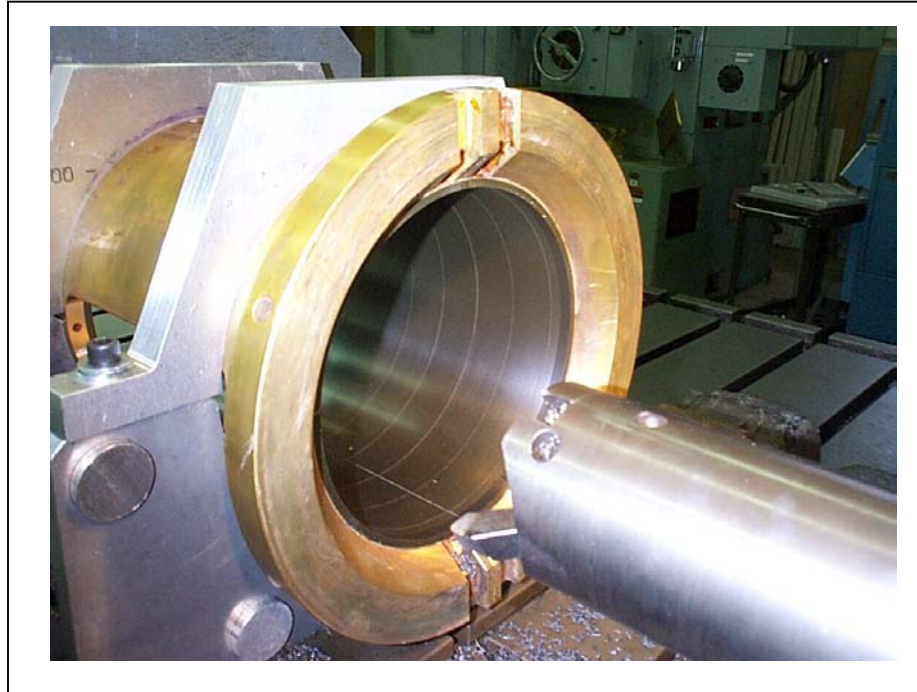
**Figure 17 Machining Vespel®-lined bearing**

Figure 17 shows one of the bearings in the process of being machined.

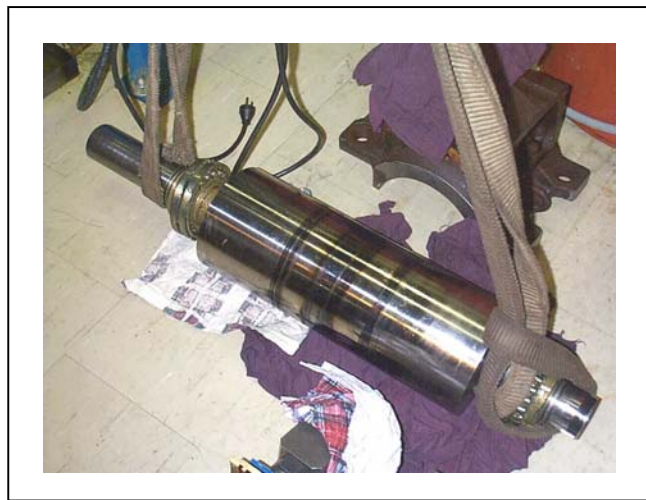
**Figure 20** Shaft after failure of the Mark 1 Vespel<sup>®</sup>-lined bearing

Figure 19 shows the heavily rubbed areas and their location in relation to the load line. The shaft after this test is shown in Figure 20.

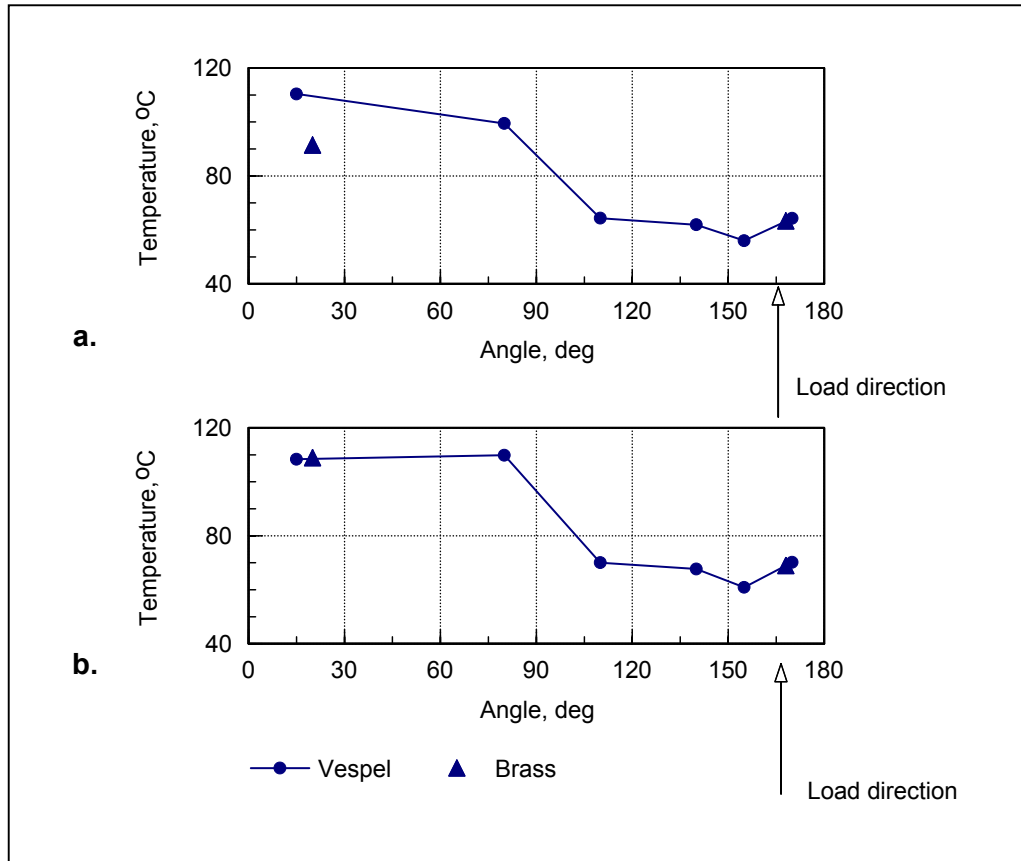
**Figure 21 Centre line temperature profile: Mark 1 Vespel<sup>®</sup>-lined bearing**  
 a. at time of failure b. immediately after removing 5000 lb. load

Measured centre-line temperature profiles from the Vespel<sup>®</sup>-lined bearing, just at the point of failure and shortly after the load was removed, are shown in Figure 21. Points of interest arising from these plots are as follows:

- The maximum recorded bearing temperature was approximately 110°C.
- At the time of the failure, a thermocouple in the brass housing, which was very close to the location of the maximum bearing temperature, recorded a temperature of about 90°C. However, by the time the load had been removed, this temperature had quickly risen to 110°C (the same temperature as the bearing).
- At the time of the failure, the maximum temperature was recorded by the thermocouple located approximately 155° from the load line.

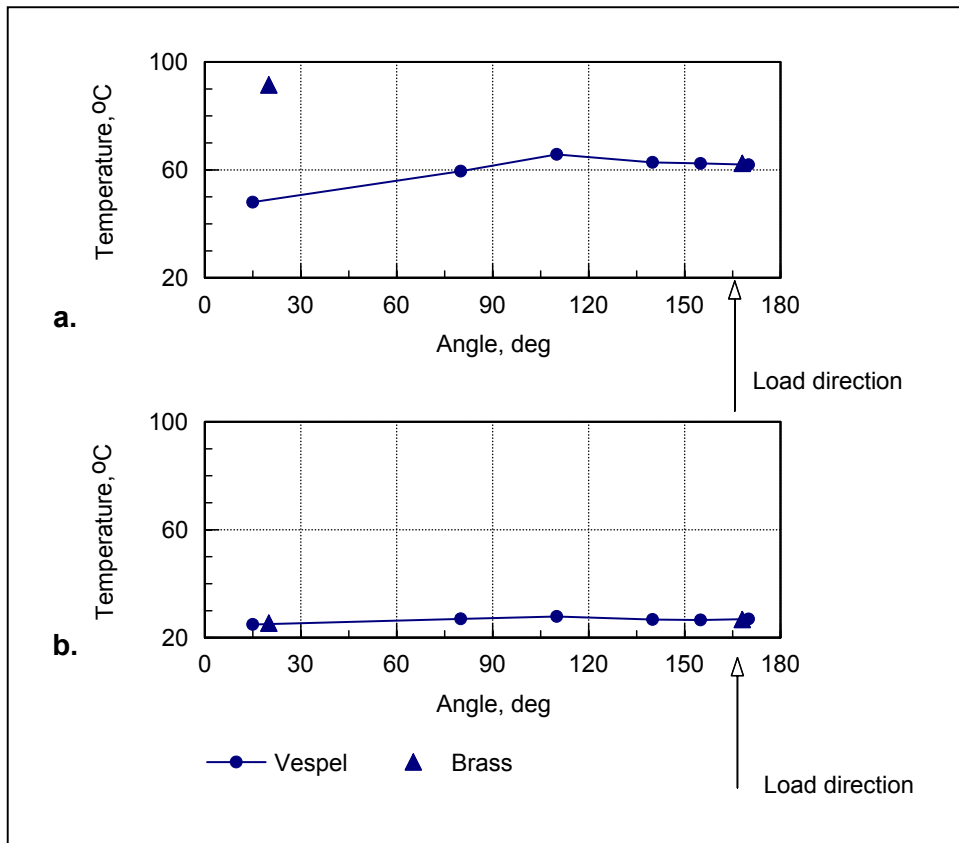
**Figure 23** Centre line temperature profiles: Mark 2 Vespel<sup>®</sup>-lined bearing  
a. 200 rpm, 5000 lb.      b. 100 rpm, 3500 lb.

Measured bearing center-line temperature profiles from the first and second tests are shown in Figure 23.

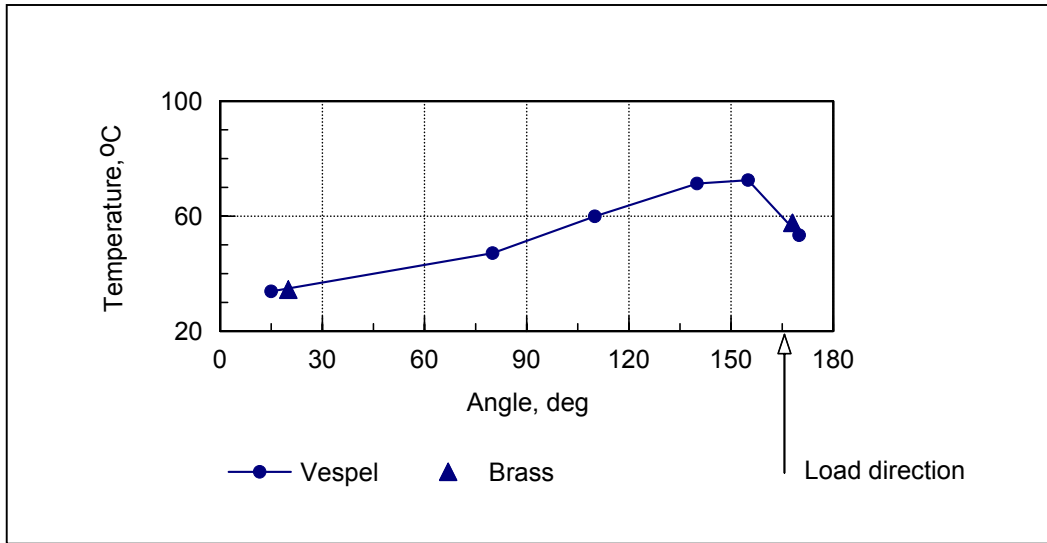
**Figure 27** Centre line temperature profile at point of failure 500 rpm, 11,000 lb. load: Mark 2 Vespel<sup>®</sup>-lined bearing (larger bore)
